CASE STUDY 4

Cost Implications of a Collapsed Underground Pipe

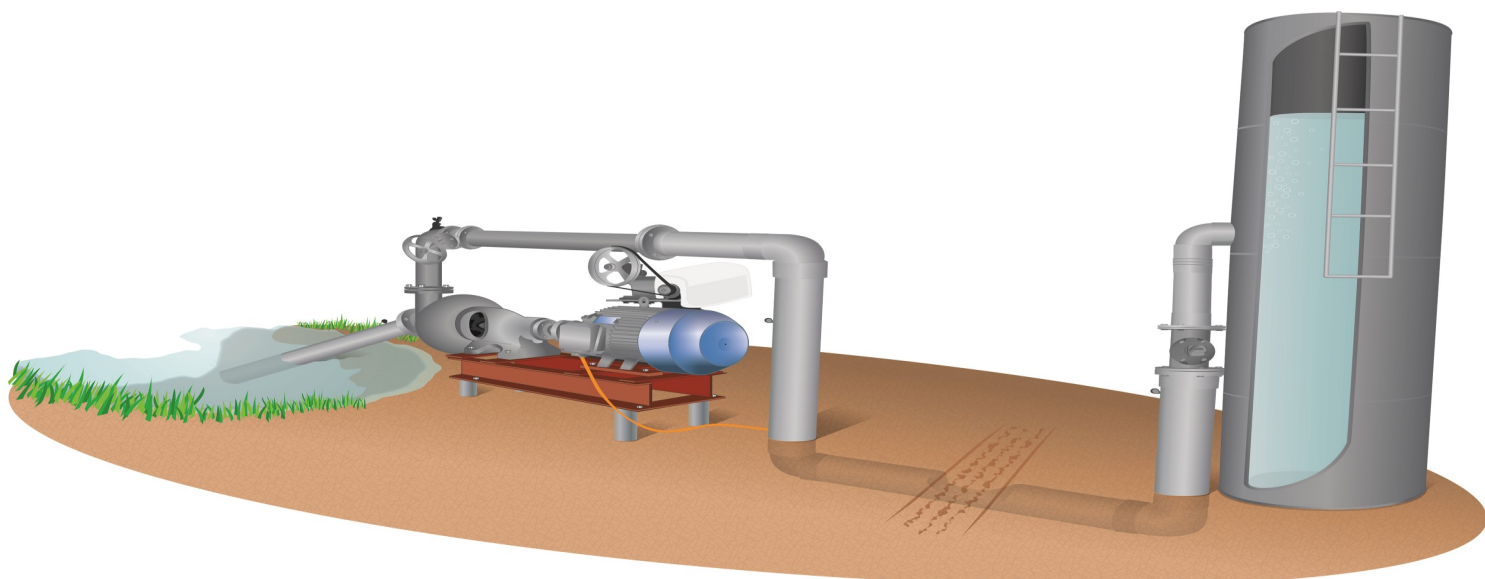
Burdekin sugarcane grower John Davenport uses two pumps to furrow irrigate 52 hectares of sugarcane using a mixture of groundwater and channel water. Prior to the energy efficiency assessment, he was quite happy with the volume of water the pumps were producing, and believed that his pumps were running efficiently. An energy efficiency assessment was carried out on his open water pump. The pump was operating at an acceptable level of efficiency for the duty being performed, however concerns were raised due to the higher than expected delivery pressure and the total power consumption required to move the water to the delivery point. A total pressure equivalent to pumping over 21 metres of vertical height was measured. With an elevation of less than 7 metres from the water supply source to the top of the delivery cylinder, located approximately 50 metres away, it was clear that the operating pressure and power consumption (or pump duty) was far in excess of what would be expected. This indicated high friction losses somewhere in the system causing excessive power consumption. Further investigations found that the pipe delivering water to the cylinder had collapsed under a roadway (see figure 1).

Figure 1—Graphic representation of the fault in the pipe underneath the roadway

As a first step in examining the cause of the high friction losses, John contracted a local plumber to investigate. The plumber inserted a camera into the discharge pipe and found that the pipe had collapsed under a roadway approximately 15 metres away from the pump. The cost of this investigation was approximately \$160.

As a result of the energy efficiency assessment, John has decided to purchase a new pump that would be better suited to the infrastructure in place and to replace all of the pipework associated with the pump. He plans to replace the entire 66 metres of six inch delivery pipe with an eight inch pipe to reduce friction losses, and to run the new pipe through a concrete cylinder under the roadway. This is estimated to cost a total of \$11,000, \$7,000 for the pipework and \$4,000 for the pump.

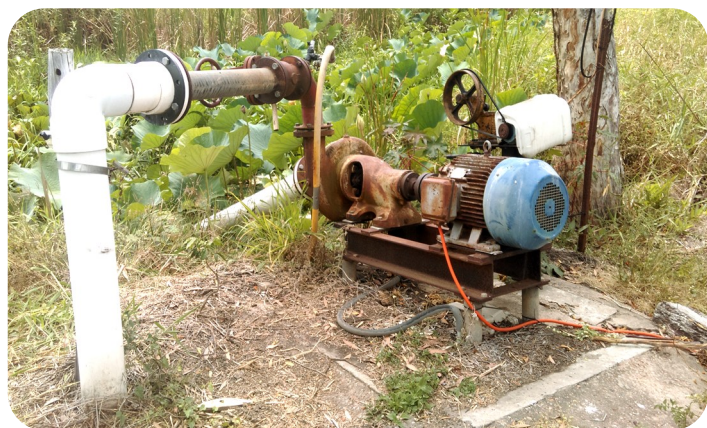
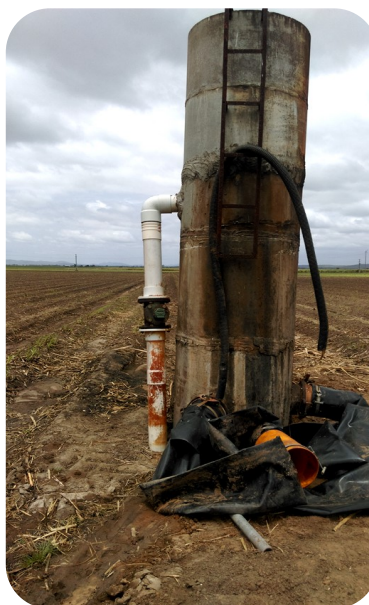
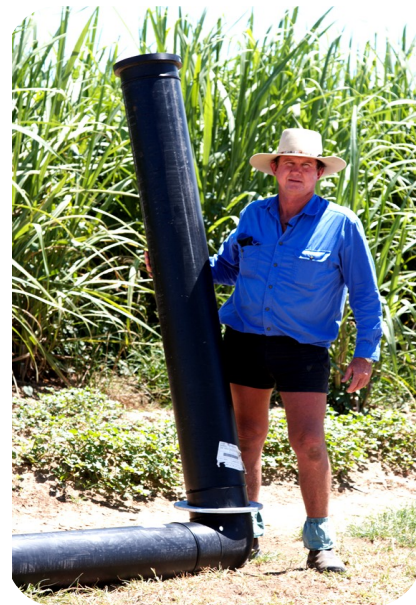
From left to right; The pump the assessment was carried out on, the water cylinder the pump delivers water to, the grower with his new pipes—ready to go into the ground when rain arrives to irrigate his crop.
