ENTRANCE VELOCITY - COST VERSUS EFFICIENCY

- (A) For the 10" diameter screen, based on 30 metre setting depth and 0.060" aperture, the following details would result for a 0.1 foot/ second entrance flow velocity.

REPORT NO: MT-09/315-A

STRENGTH TESTING OF 102MM (4") HOSE ASSEMBLIES

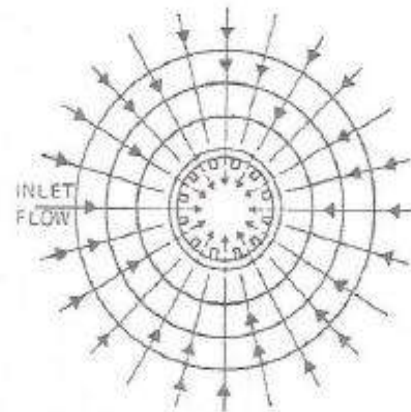
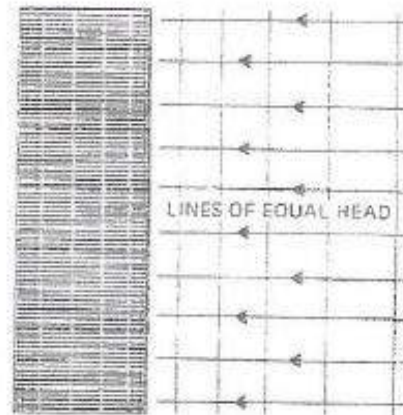
FLOW PATTERN OF CONTINUOUS SLOT WELDED WEDGE WIRE SCREEN

LINES OF EQUAL HEAD

CONTINUOUS SLOT WELDED WEDGE WIRE SCREEN

The diagram above shows that there are no obstructions to the flow of water entering the screen. The water does not have to alter course either horizontally or vertically to find openings — consequently an all round even flow is obtained with little or no turbulence.

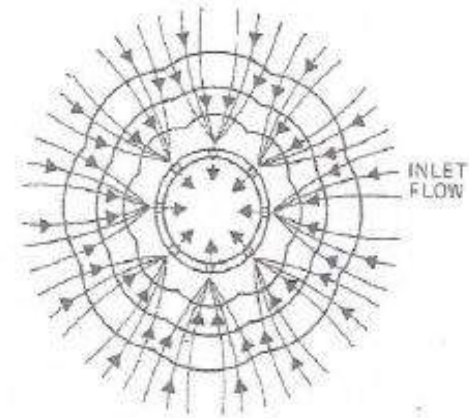
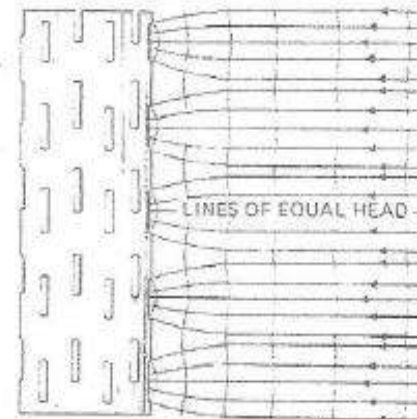
SLOTTED OR PERFORATED CASING

LINES OF EQUAL HEAD

Here we see the flow pattern of water entering slotted or louvred casing. The water converges on slots causing turbulence, aeration and high entrance velocity.

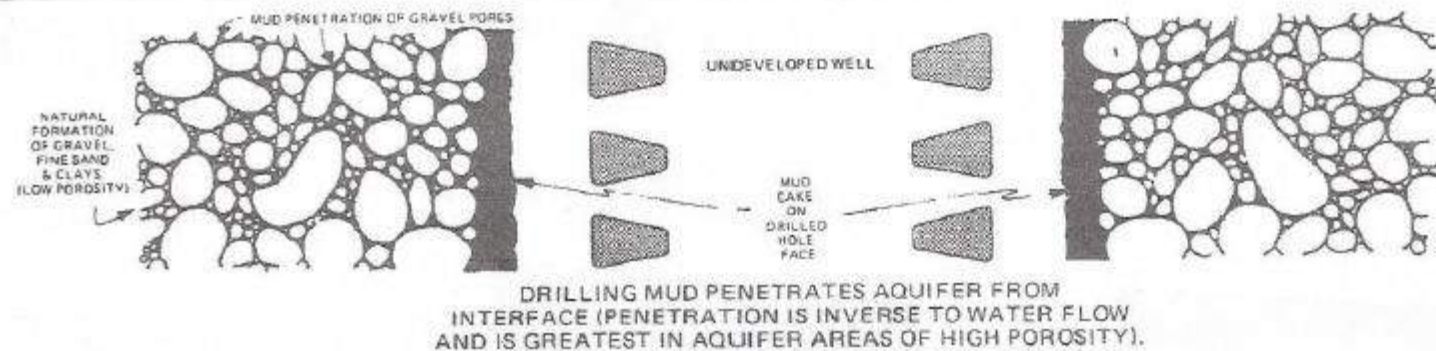
The detail below diagrammatically indicates:

- A *Aquifer contamination caused by the drilling operation.*
- B *Increased Porosity obtained by correct well development.*

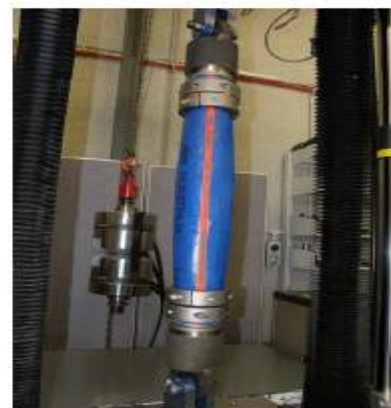
**FIG.1
TEST SET-UP**

Testing was conducted by gripping the Stainless Steel threaded couplings in a tensile testing machine (See Fig.1). Tensile load was then applied at a constant rate and was continued until rupture of the hose had occurred. Load and extension data was recorded throughout the test.

As can be seen from Figure 2, failure of the hose assemblies occurred by rupture of the hose fabric. This mode of failure was observed for both tests. Test data curves showing the applied tensile force and extension for each test are provided in Figure 3. The recorded failure loads for each hose are as follows:

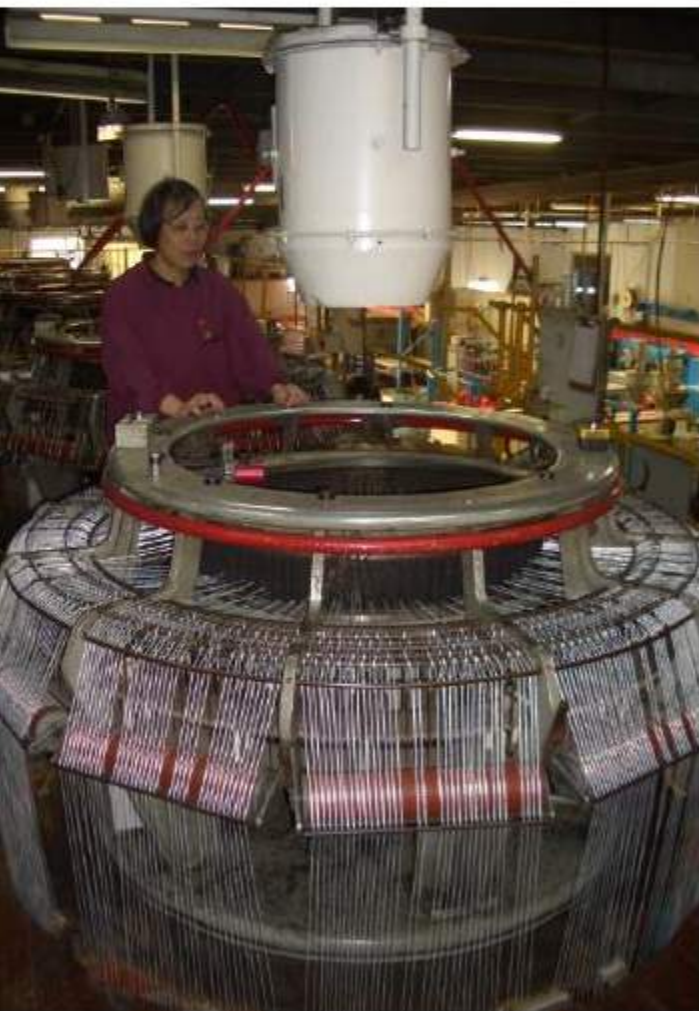
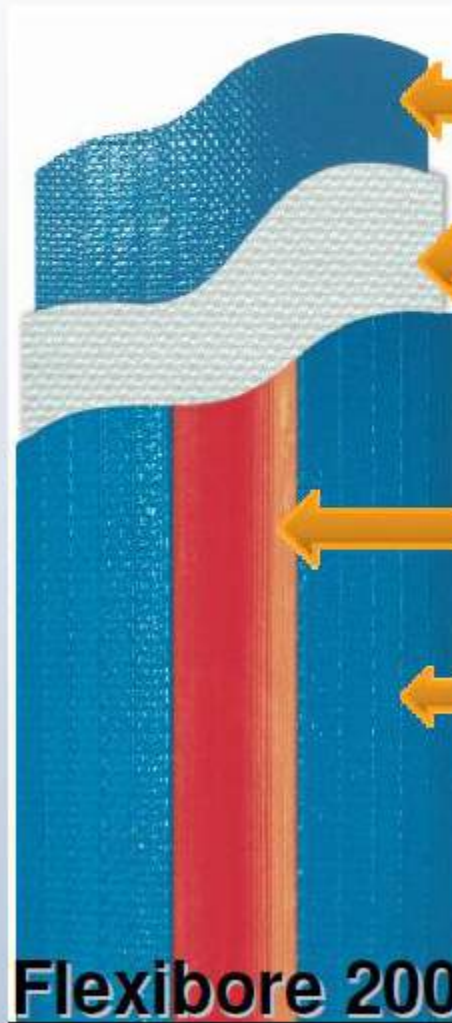
Flexibore 200

Woven on Looms

Size Range Diameter
32mm to 200mm

Impregnated polyurethane lining bonded to outer cover which eliminates separation

Woven textile fabric of high tenacity polyester

Strip with loops every meter from which to secure power cable

Tough polyurethane cover

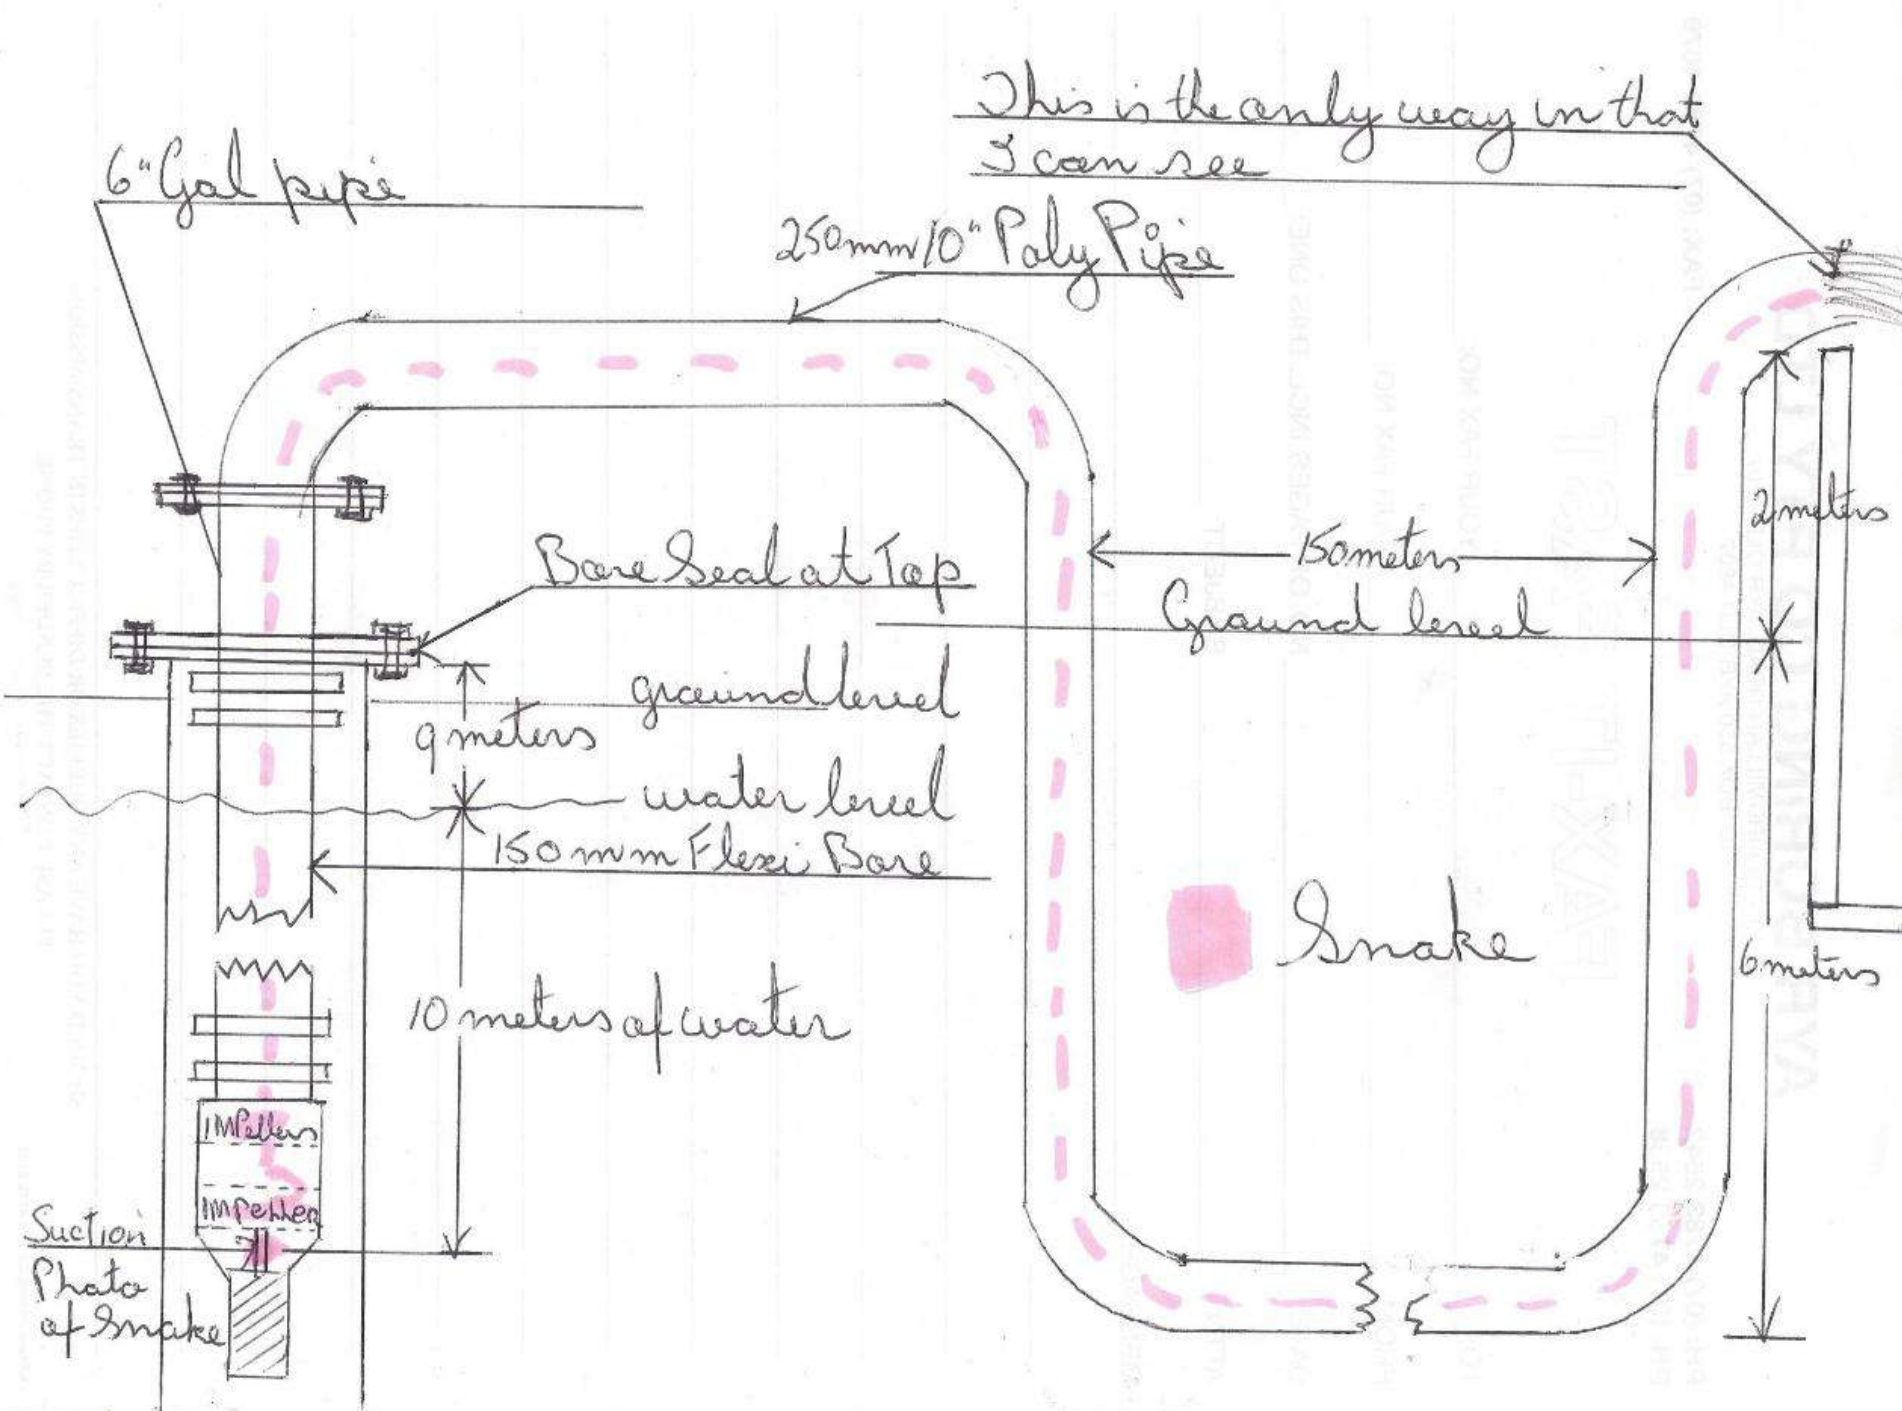
6" Gal pipe

250mm/10" Poly Pipe

Bore Seal at Top

9 meters ground level

150 mm Flexi Bore

10 meters of water

Impeller

Snake
